3-year PEM installation at Hillsboro Beach, FL.

Kenneth Christensen EcoShore Int'l Inc. - Sandy Nettles N.S. Nettles & Associates Inc. - Frank Gable PhD Florida Gulf Coast University

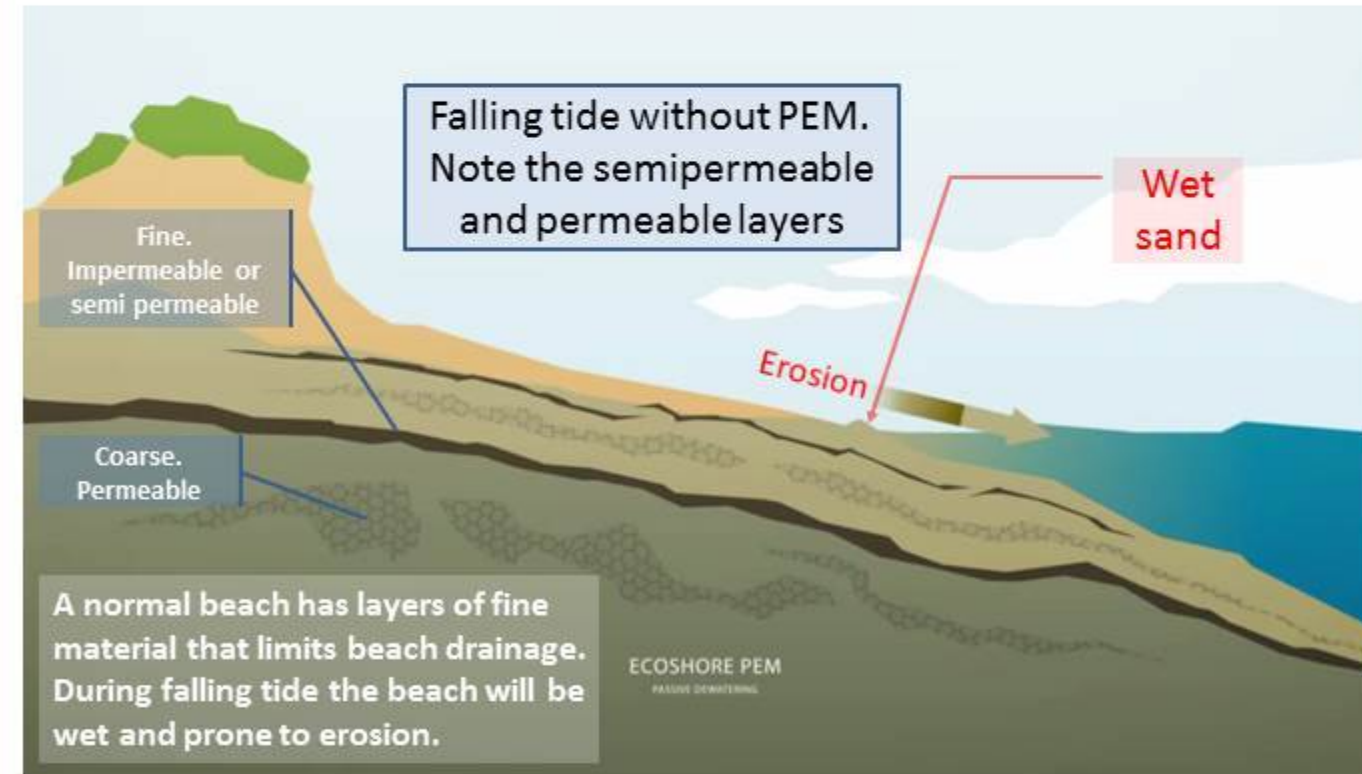
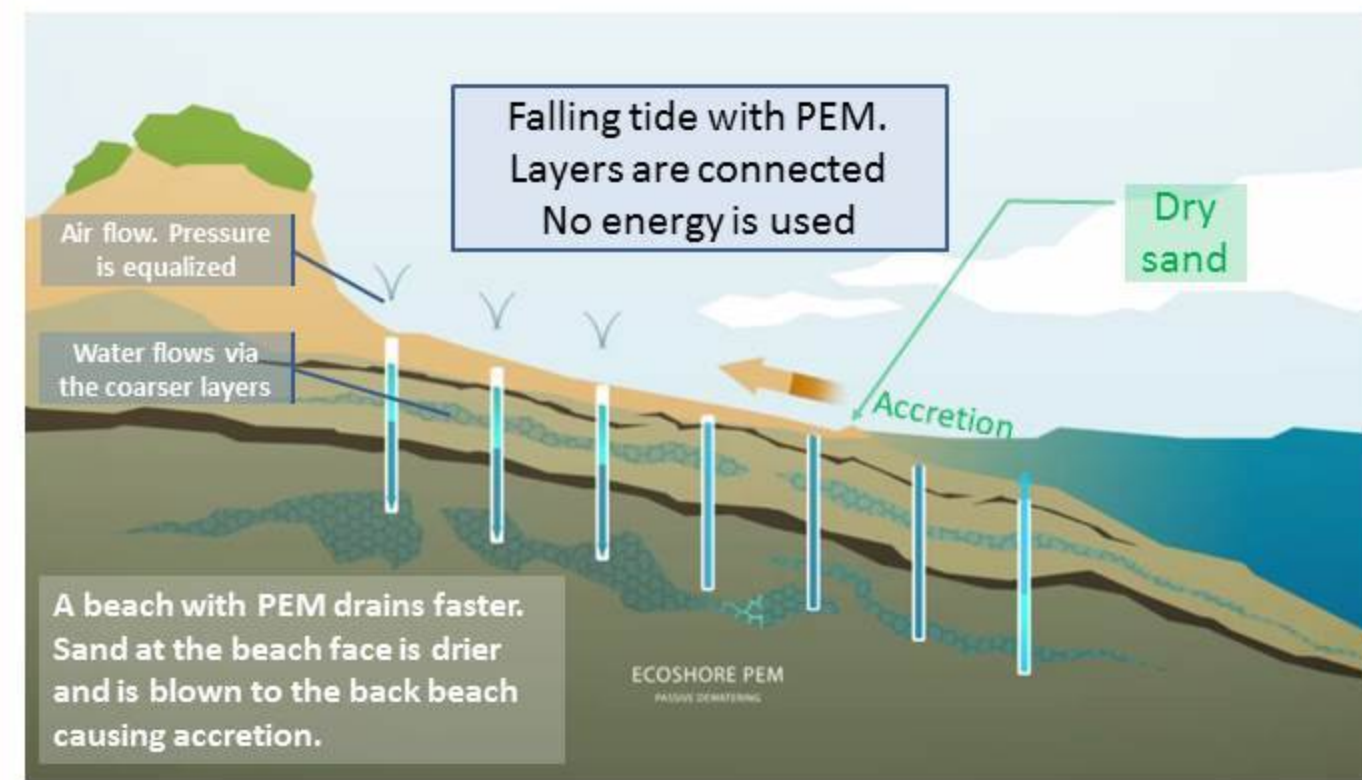
Pressure Equalizing Modules (PEM) are passive drains installed vertically in a beach below the surface. PEM enhances the beach's ability to drain. More water percolates through the top layer of the beach causing extra sand grains to be deposited on the beach rather than pulled away by the swash. The wind will blow the dry sand further onto the beach and the dunes.

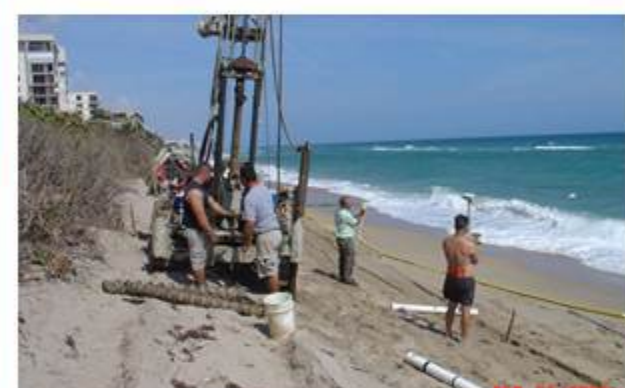
- Pre-PEM installation February 2008**
- Validate physics: Installed water wells/PEMs - Very high groundwater level
- PEM Installation in February 2008**
- Installation completed in 2 weeks
 - 90 PEMs installed with drill
 - Very poor beach condition
 - >50% of PEMs were reduced in size

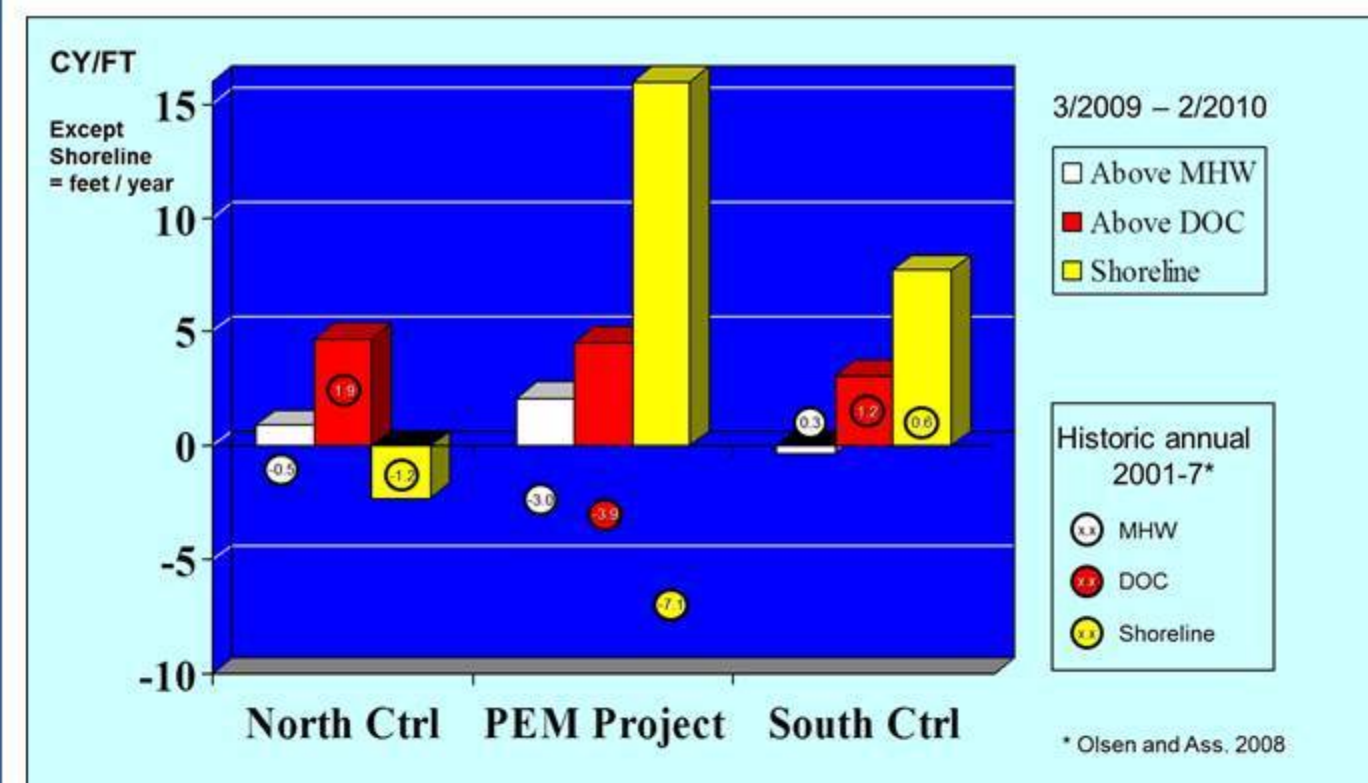
Projects are often influenced by weather events distorting data. During the second year the weather was stable and no nourishments took place, making it an ideal observation period. Below are the data from the 2nd full year 3/2009 - 2/2010. The historic values (2001-7) are in circles. As can be seen the North and South control fall within the norm. Only the PEM project area is performing different from historic. The PEM project area was supposed to lose sand but gained sand.

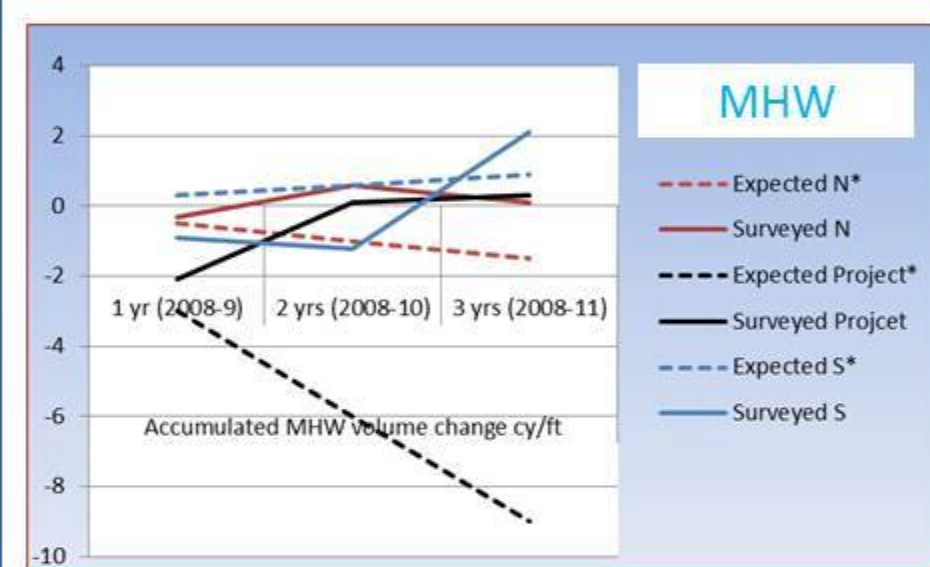
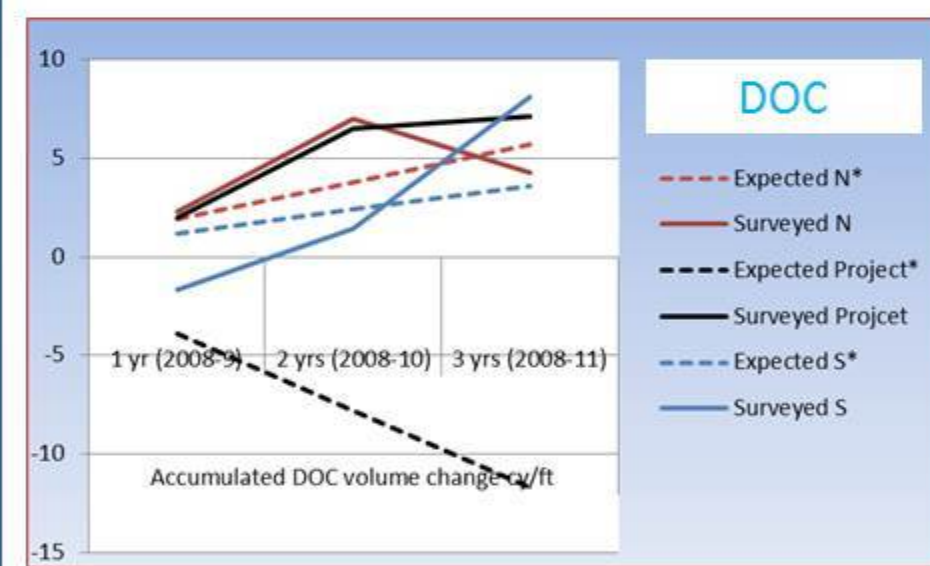
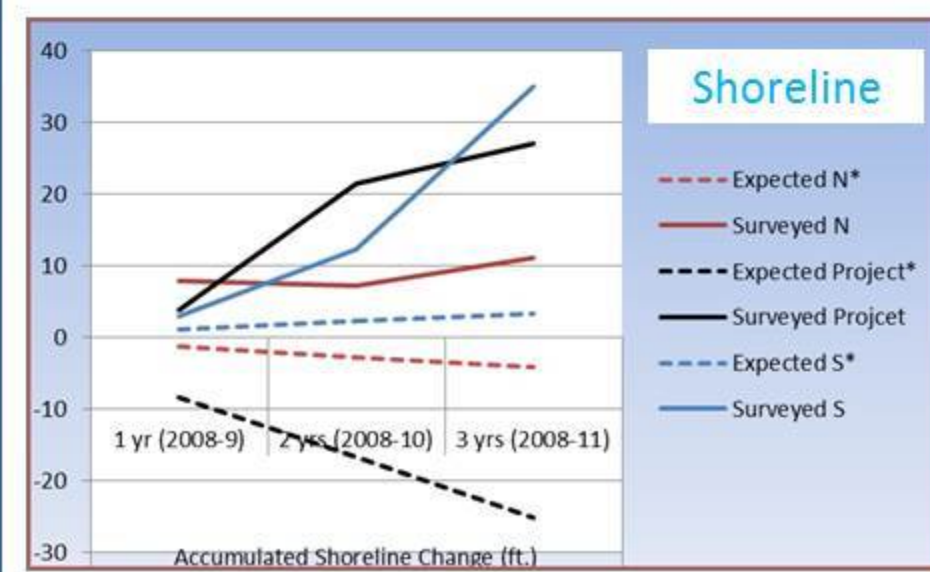
Below the 3-year historic/expected performance is compared to the actual performance in the North and South controls and PEM project area. Of special interest is if the South control is performing worse than expected as this may be an indication of downdrift erosion (robbing Peter to pay Paul).

In all of the graphs the South control area (solid blue line) are doing better than historic data (dotted blue line). This indicates no downdrift erosion. Instead downdrift accretion is observed, which is a typical effect of PEM

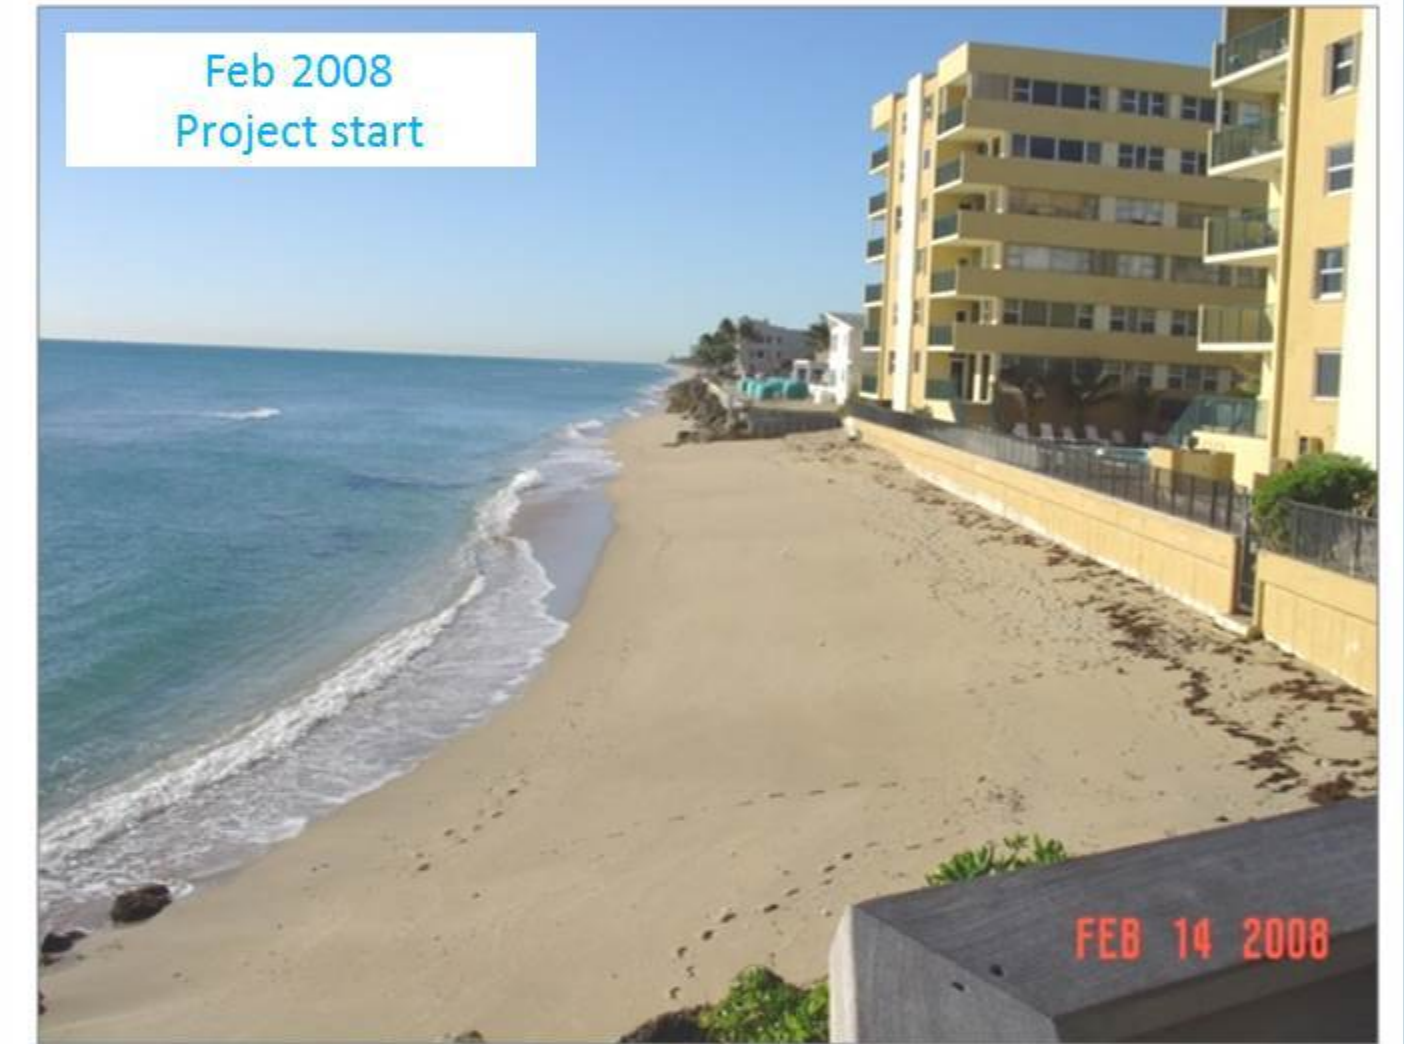
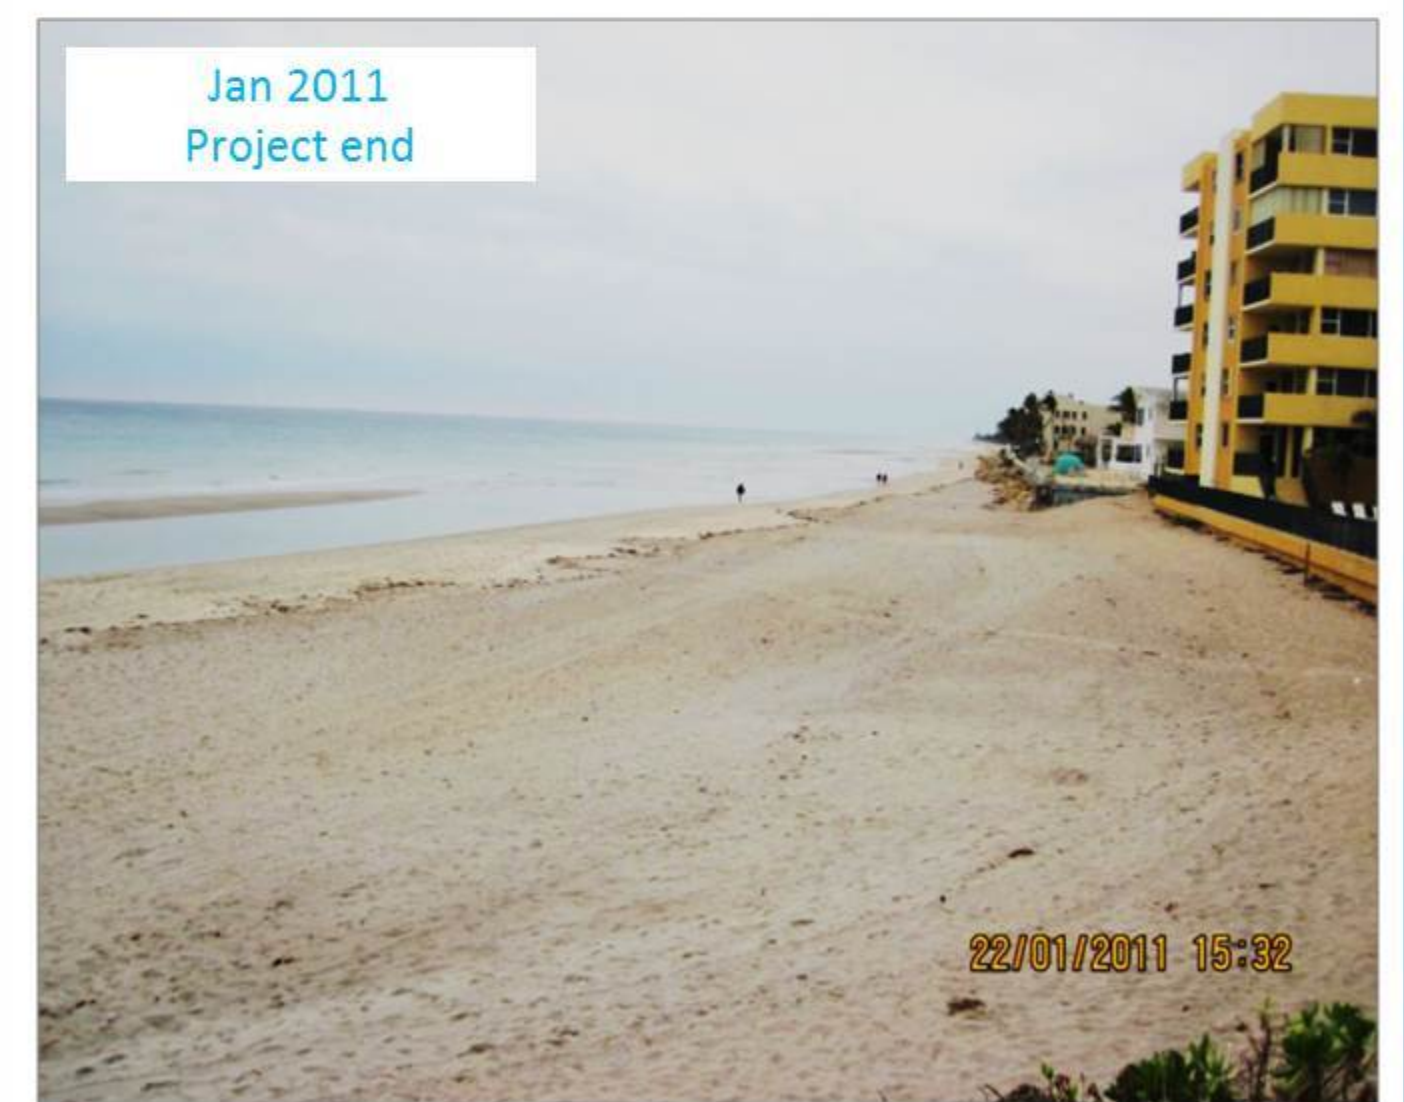
The photos below are shot at low tide and show the beach from R6.5 looking South.

The two photos above from project start and project end indicates a successful project, a conclusion which is also supported by the survey data. However; the Town decided to end the PEM project and have a traditional nourishment. As a result the PEMs were removed and 340,000 cubic yards of sand were placed from R7-12 in April 2011 at a cost of \$5.6 M. How the beach performed can be seen from the photo below.
