RESULTS OF A 3-YEAR BEACH EROSION CONTROL PROJECT IN HILLSBORO BEACH, FLORIDA, UTILIZING PRESSURE EQUALIZING MODULES (PEM)

Kenneth W. Christensen, EcoShore Intl', Inc., kwc@ecoshore.com
Frank J. Gable, Florida Gulf Coast University, fgable@fgcu.edu

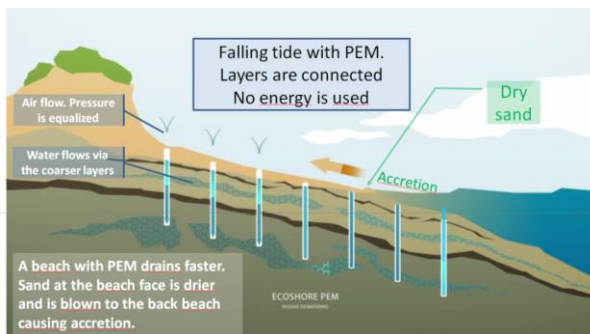
PEM's are hollow permeable tubes inserted vertically into a beach in a grid from the dune to the mean low waterline. The tubes are placed one to three feet under the beach surface making the installation invisible to the naked eye. The exact grid design depends on the local conditions. The tubes are not connected and no energy is used to operate the system. The tubes penetrate and connect the different strata of the beach allowing the water to find the easiest way out via gravity during falling (outgoing) tide, typically via a coarser layer, resulting in improved drainage (see Figure 1).

Figure 1 - Working mechanism of the PEM system

A connection to the atmosphere through a vent at the top of the tube allows pressure to be equalized, hence the name PEM - pressure equalizing modules. As a result, the time period where the beach is saturated and prone to erosion is reduced. With improved drainage more sand is deposited in the swash zone and via aeolian transport moved to the back beach and dunes resulting in reduced erosion and - more often - accretion.

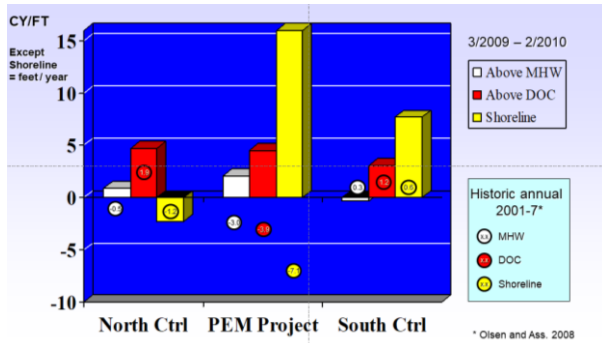
During the second year the weather was stable and no nourishments took place, making it an ideal observation period. Below in Figure 2 are the data from the 2nd full year 3/2009 - 2/2010. The historic values (2001-7) are in circles. As can be seen the North and South control fall within the norm. Only the PEM project area is performing different from Historic. The PEM project area was supposed to lose sand but gained sand.

Figure 2 - Second full year. No nourishments. No storms

During the project period no hurricanes affected the area. During the second 12 month period of operation no major storms or nourishments took place (see Figure 2).

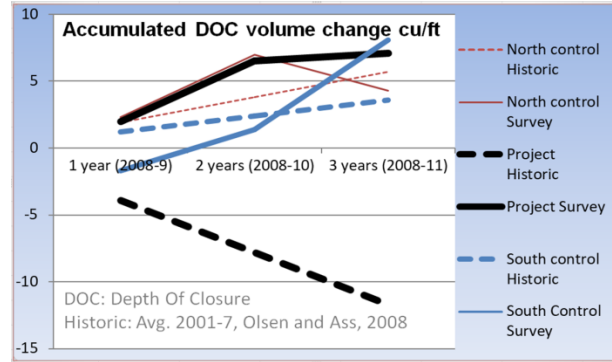
The DOC volume change during the 3-year period can be seen in Figure 3. The PEM project area is gaining sand instead of historically losing sand. The North and South control lie within the norm. The predominant littoral drift is from North to South and if PEM had caused any negative downdrift effect the South control would be affected. However, the South control performed slightly better than Historic documenting that PEM cause no negative downdrift effect.

Figure 3 - Accumulated DOC volume change

During storms a PEM area is proven to lose less sand and buildup faster. PEMs cause no down-drift erosion (see Figure 3), no escarpments and have a proven turtle friendly design. The carbon footprint is minimal as they require no pumping to operate.

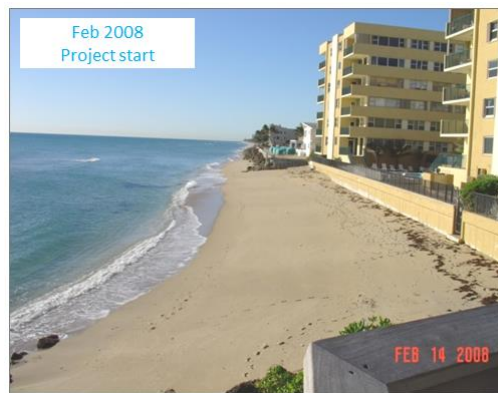
At the end of the 3-year period the erosion in the PEM project area had stopped and the beach had gained sand from R monument line to MHW, to -5ft, and to DOC. Shoreline in the project area that historically lost 25 ft. in 3 years gained 26 ft. The North and South control areas were not negatively affected. Photos in Figure 4 and 5 were shot at low tide from R6.5 at project start and end.
